SH8 Beaumont Slip Active Warning System

Coastal Otago Hybrid Maintenance Contract

Beaumont Hill Slip

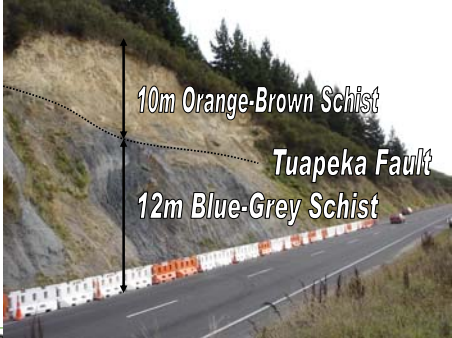
10m Orange-Brown Schist
Tuapeka Fault
12m Blue-Grey Schist
