WHEN FLASHING IS GOOD

PEDESTRIAN CROSSING WARNING LIGHTS TRIAL

Author / Presenter: Mike Smith, NZCE (Civil), MET, MIPENZ, CPEng, REA

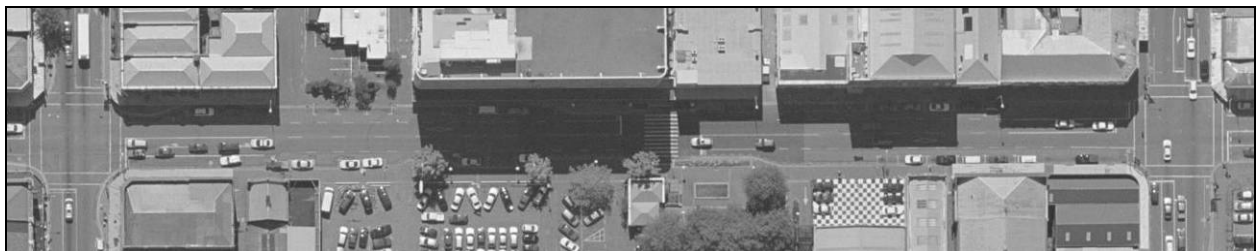
Figure 1: Tuam Street Pedestrian Crossing Location

The Tuam Street pedestrian crossing in Christchurch is a mid-block crossing located outside the Civic Offices. The crossing was subject to a road safety audit carried out in June 2003 following a collision between a pedestrian on the crossing and a car in February of the same year. Refer to Figure 1 and Figure 2 for location and layout details.

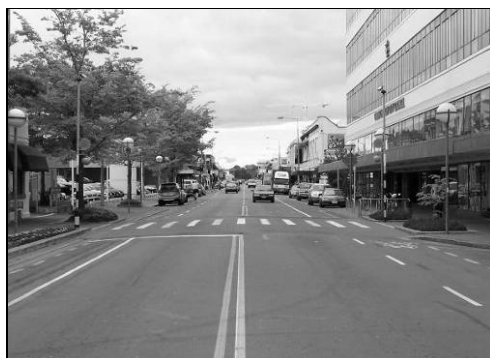
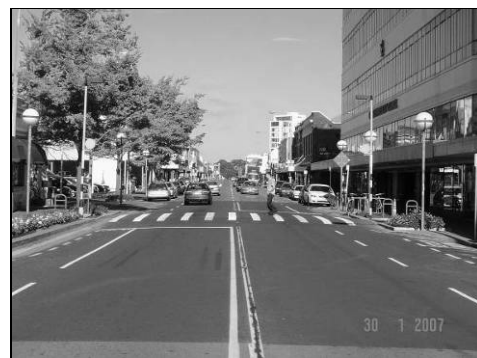
Figure 2: Tuam Street Pedestrian Crossing 'Before' and 'After'

The 'Before' figure shows the low pedestrian platform and vegetation obstructing sight lines. The 'After' figure shows the new raised platform, low planting and improved sight lines. The in-ground flashing studs are located along the road centreline and across the road near the limit line.

The safety audit recommended horizontal and vertical alignment changes to the roadway at the Tuam Street crossing. The pedestrian crossing was reconstructed to the new design road shape to enhance awareness and to improve drainage. In addition, changes to the kerbside parking with the relocation of the loading zone to the departure side of the crossing improved intervisibility between the driver and the pedestrian.

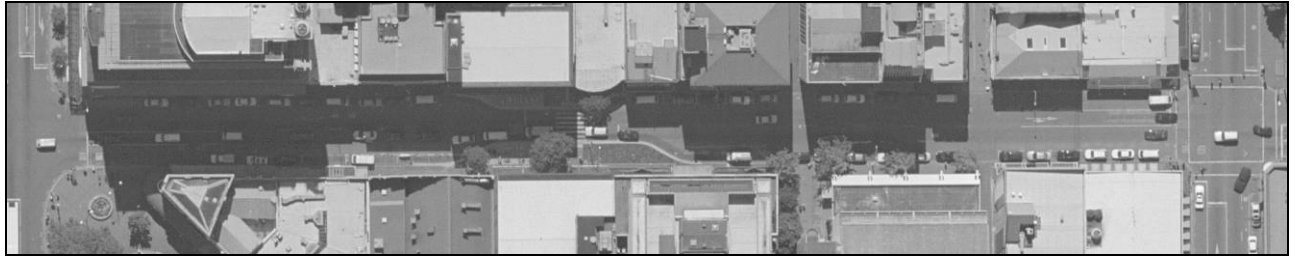
Figure 3: Hereford Street Pedestrian Crossing Location

Investigations at a second (uncontrolled) crossing point for pedestrians in Hereford Street near Westpac Lane in Christchurch highlighted the need to improve this facility.

An earlier study indicated that the crossing point should give priority to pedestrians. The warrant conditions for a 'Zebra' pedestrian crossing facility were met. The Council initiated a project to construct kerb build-outs and install a 'Zebra' pedestrian crossing on a raised platform at Westpac Lane early in 2006. This work was completed in early 2007. Refer to Figure 3 and Figure 4 below for location and layout details.

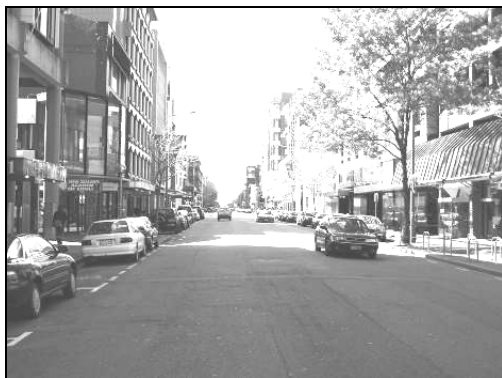
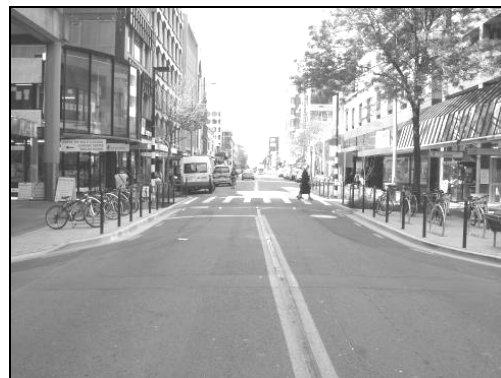
Figure 4: Hereford Street Pedestrian Crossing

The implemented site improvements included the replacement of some kerbside parking with a kerb build out on each side of the road, bollards and chain to restrict pedestrian crossing movement away from the crossing point, improved lighting at the crossing and the installation of in-ground flashing warning lights.

The Hereford Street site was a new facility, and concern was raised during the consultation process as to the operational safety of a new mid-block pedestrian crossing in the CBD. Concerns expressed reflected the concerns raised at the current Tuam Street pedestrian crossing.

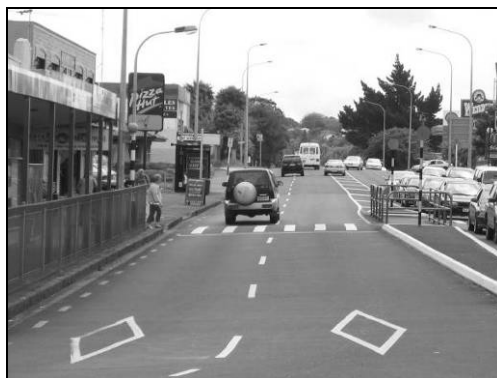
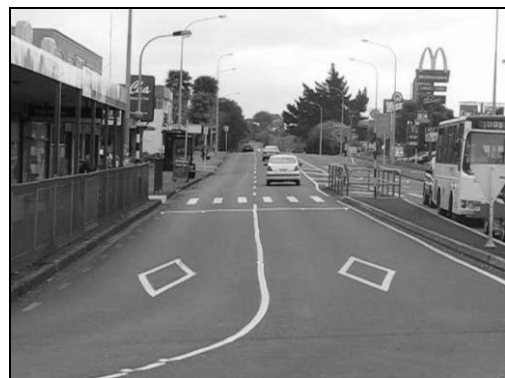
Figure 6: Mt Albert Road Pedestrian Crossing 'Before' and 'After'

The crossing used for the trial is on the departure leg of the roundabout on Mt Albert Road. It is located approximately 35m from the intersection and, due to the closeness of the corner building and a pedestrian safety railing, sight visibility to the pedestrian crossing is compromised for motorists exiting the roundabout. The complexity of the roundabout also diverts drivers' attention away from the pedestrian crossing. By the time drivers are aware of someone on the crossing they often have little time to react to the situation.

The other problem is the two-lane approach to the pedestrian crossing. A conflict is created when one driver stops and the driver of the vehicle in the other lane continues to pass the stopped vehicle unaware that the other driver has stopped for a pedestrian. Numerous near hits and vehicle / pedestrian conflicts were recorded for the Royal Oak pedestrian crossing.

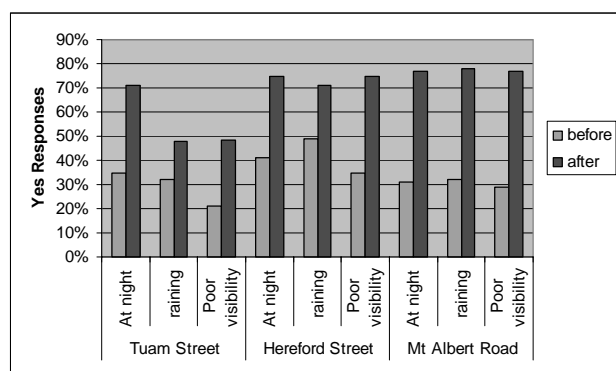
Figure 8: Pedestrian and Driver perception responses

Pedestrian perception of the crossing safety with and without active flashing lights.

Driver response to compliance to yield under specified conditions with and without flashing lights.

- Pedestrian participants at all sites have indicated that they feel safer using the crossings with the new warning lights in place;
- The largest shift from feeling unsafe to feeling safer relates to the multi-lane trial site in Auckland;

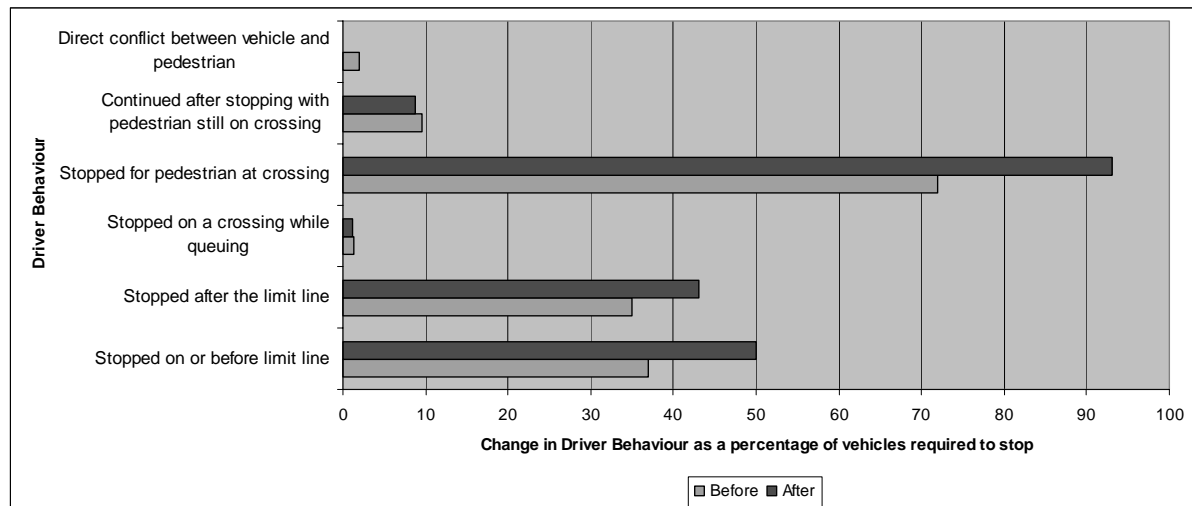
Figure 9: Change in Driver Behaviour Following Implementation of Warning Lights – Tuam Street

- There has been an **increase** (ranging from **5% to 21%**) in the proportion of drivers stopping for pedestrians at the trial sites, thus reducing delay for pedestrians;

- There has been an **increase** (ranging from **4% to 20%**) in drivers stopping on or before the limit line;
- The number of direct **conflicts** has **reduced** from 2% to virtually nil at each site;
