## Effectiveness of Transverse Road Markings on reducing vehicle speeds

# Effectiveness of Transverse Road Markings on Reducing Vehicle Speeds

NZTA research report 423

Andrew Martindale - Transport Engineer  
Cherie Mason – Senior Road Safety Engineer

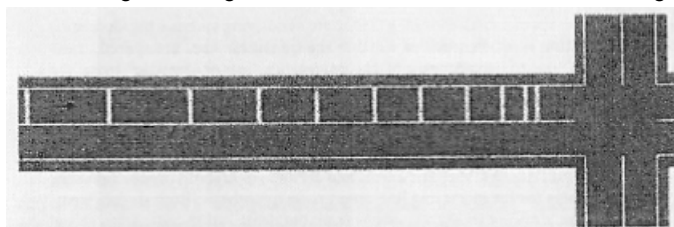
- Transverse road markings are a speed mitigation device. They can be generally defined as:  
*“A series of marked (either flat or raised) transverse bars placed across the road in the direction of traffic flow”*
- It is thought that transverse markings either:
  1. Give a driver the sense of acceleration through an optical illusion in the driver's visual field
  2. Act as large warning device, which is difficult for a driver to ignore.

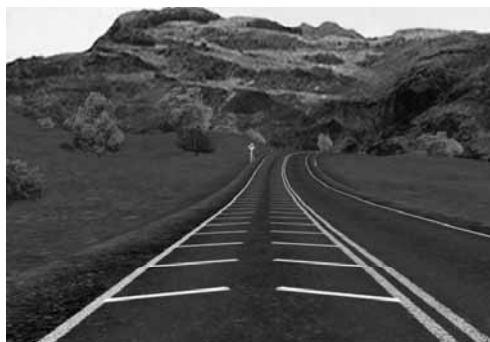
- NZ research using driving simulators for a number of trials of transverse road markings/perceptual countermeasures
- The trials showed speed reductions and/or changes in lane position for transverse markings in high speed rural environments.

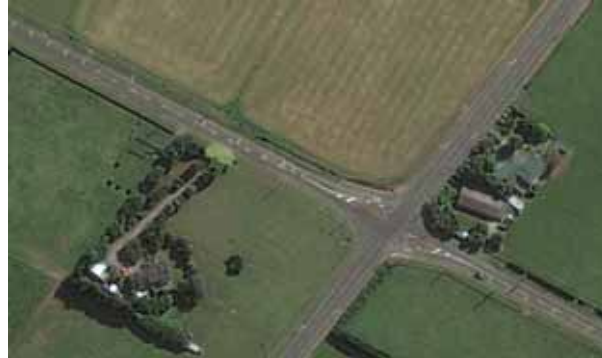
- In NZ no official field trials involving speed assessment had been documented prior to this NZTA project.
- Not mentioned in current NZ legislation, guidelines or design standards.

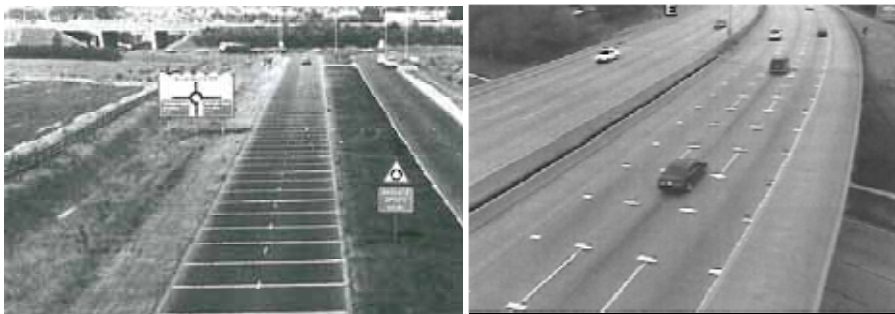
- Research into understanding their effects and properties completed in Australia, UK & USA.
- Used extensively at motorway off-ramps and roundabouts in the UK.

Source: (left) Helliar-Symons et al, 1981 (right) high-speed curve layout in Milwaukee (Gates et al 2007)

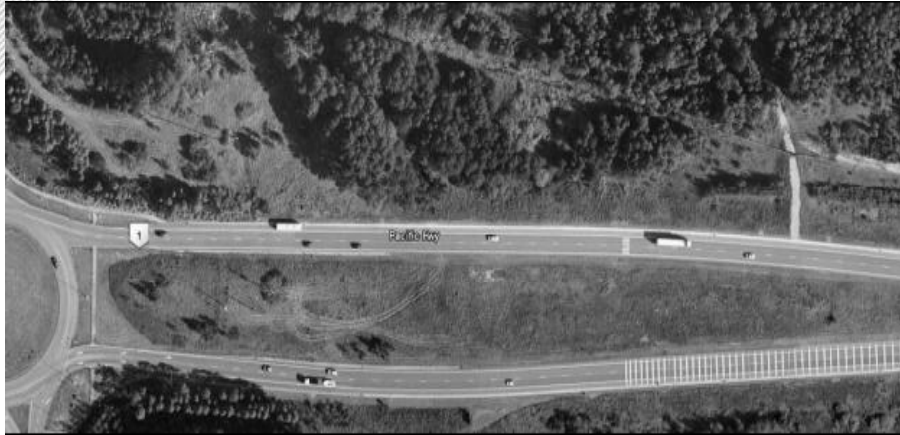
Pacific Highway in New South Wales, Australia (photo courtesy of Google Earth Pro License)

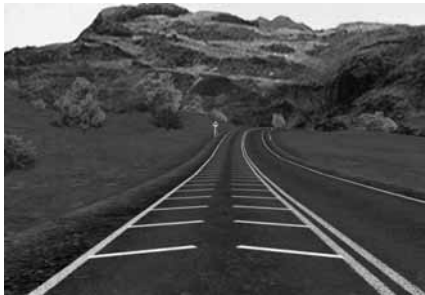
Simulator Trial Marking

- In conjunction with NZTA, a layout consistent with NZ research completed by Dr. Charlton was developed for field trials.
- Layout had to be re-designed conservatively due to concerns it may be too radical for NZ drivers to comprehend, possible wet weather issues and because of motorcyclist concerns.

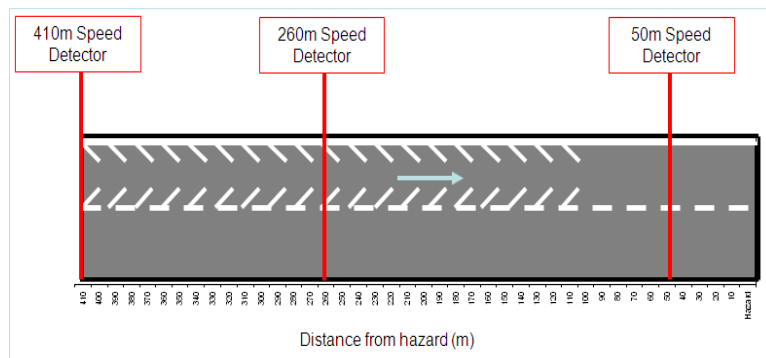
- A before/after assessment of vehicle operating speeds travelling towards each trial site.
- Speed Measured two weeks before, after and six months after the installation of the marking treatment.

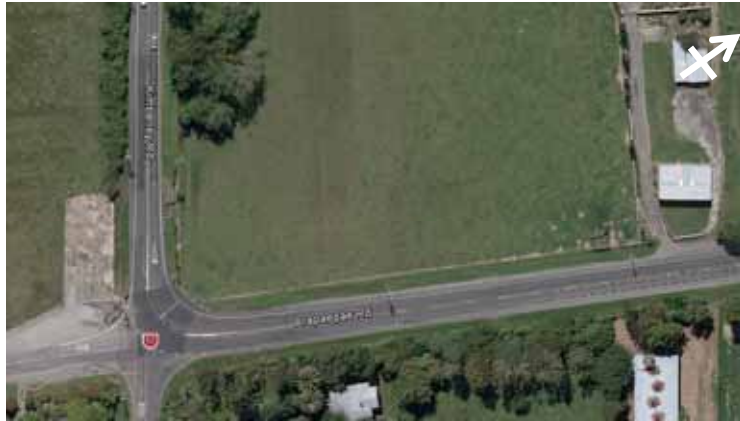
- Southbound approach to the Kimberley Road / Arapaepae Road intersection on SH57 (RP 0/2.083)

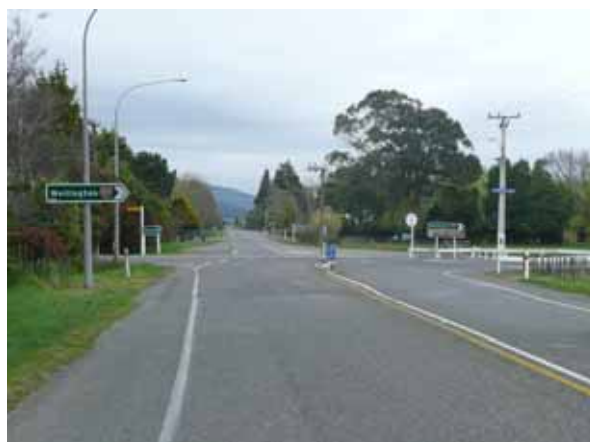
- 7 loss of control crashes between 2004-2008 where excess speed was a factor on this southbound approach.

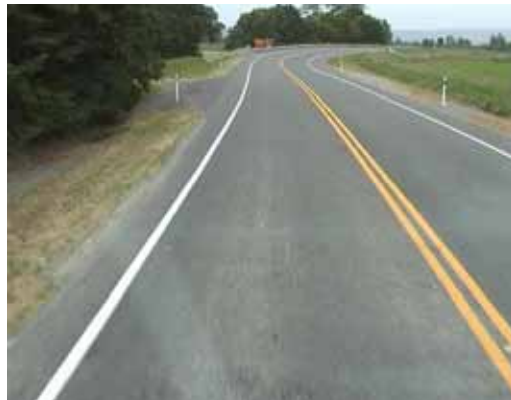
- Safety issues with the bridge not very wide. Drivers approaching it too fast without seeing farm traffic using the bridge

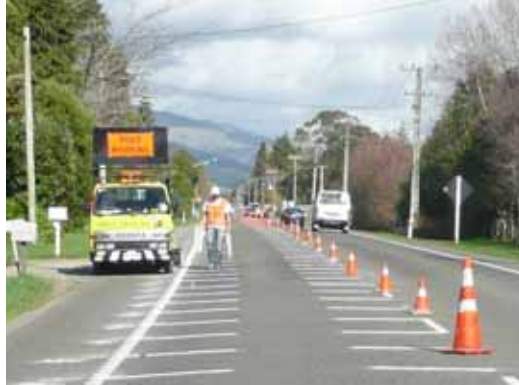
- Integrated Traffic Solutions installed the markings for us at both trial sites. Took about 3 hours per site to install.
- \$2,500 per site, but more than half of cost due to TM.

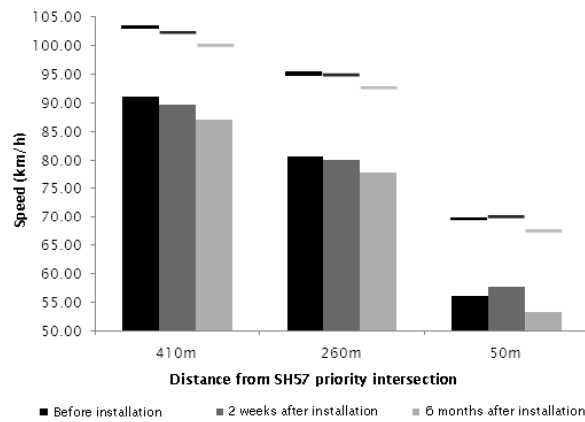
- At Trial Site 1 vehicle speeds reduced at all measurement locations in the long term (statistically)

- Largest speed reduction effects were clearly at the start of the marking treatment.
- Drivers have appeared to slow down out of precaution due to the alerting properties of the lines.
- Because of the length of the marking treatment, drivers had enough time to return to their pre installation speed at the treatment mid-point.
- But, drivers are likely to be more aware of the visual cues of the intersection/bridge which is why they arrived at a reduced speed 50m from the hazard.

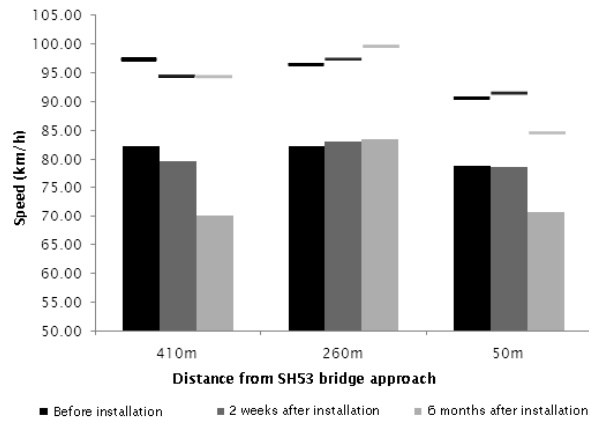
- At Trial Site 2 vehicle speeds dropped at both the start & end of the treatment length (statistically)

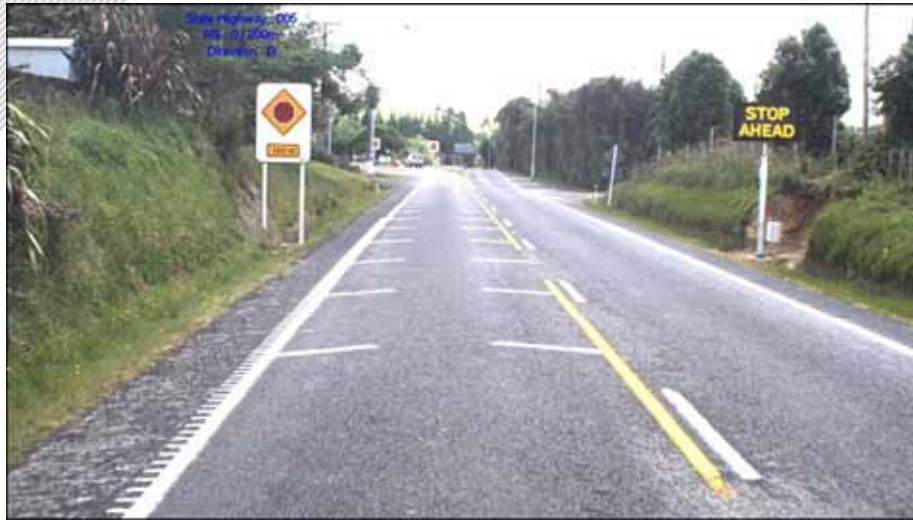
## Post Trial

- There were no crashes for the one-year period (August 2009-2010) at the SH53 bridge up until the markings were removed as part re-seal maintenance.
- There have been no crashes at the intersection since the lines have been installed at SH57 (August 2009 – January 2012)
- International interest in research findings.
- The markings have been installed at further locations in conjunction with other measures in NZ.
