TECHNICAL NOTE

**TRIAL OF VEHICLE ACTIVATED ELECTRONIC SIGNS
FOR IMPROVED DRIVER AWARENESS AT KNOWN CRASH SITES
IN TASMAN AND MARLBOROUGH DISTRICTS**

This technical paper discusses a recent trial of electronic vehicle activated permanent warning signs installed at sites in Tasman and Marlborough Districts during mid 2009.

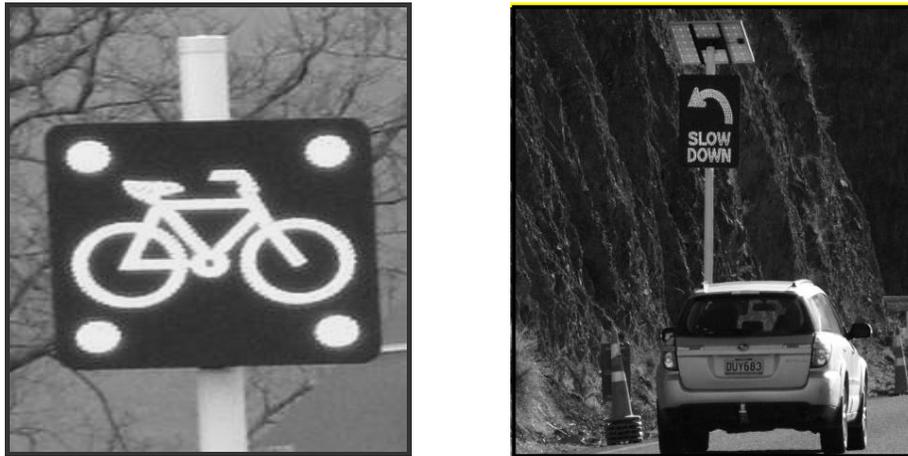
Figure 1: Cycle activated cyclist warning sign (left), vehicle activated curve warning sign (right).

- Tasman District:
 - SH60, Appleby Bridge - cycle activated cyclist warning signs.
- Marlborough District:
 - SH1, Dazzle Corner - vehicle activated curve warning signs.
 - SH1, Butter Factory Corner, Riverlands - vehicle activated curve warning signs.
 - SH6, Pak Lim's Corner, Renwick - vehicle activated curve warning signs.
